AIRCRAFT ACCIDENT REPORT

AMERICAN AIRLINES, INC., LOCKHEED ELECTRA, N 6101A,
IN THE EAST RIVER, LA GUARDIA AIRPORT, NEW YORK,
FEBRUARY 3, 1959

SYNOPSIS

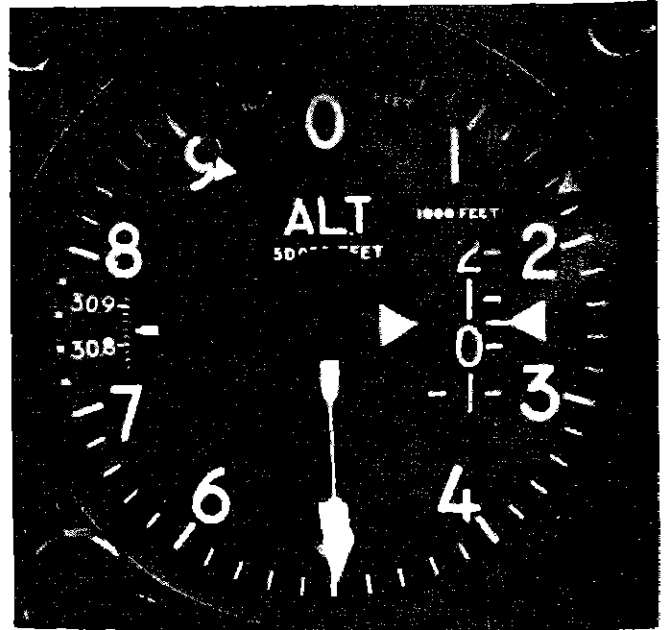
PRECISION DRUM TYPE ALTIMETER

Because of the novel presentation components of the altimeter, serious consideration has been given the possibility that the pilot misread the altitude indication and thereby permitted or caused the aircraft to deviate vertically from the desired flight path. While some incidents have been reported in which a pilot had misread the 1,000-foot scale on the small drum, no such error could conceivably be involved here. The altitude presentation below 1,000 feet is accomplished by a pointer the indications and appearance of which are, for all practical purposes, identical to those used by the crew in other aircraft types and the interpretation of which calls for no new or different evaluations on the part of the pilot.

The reversed sensing of the altimeter setting numerals has already been mentioned. While an erroneous setting might result from this condition, the possible order of error would be very small indeed. Unlike the primary instrument flight reference which is frequently "generalized" by approximate positions of pointers or indicators, the altimeter setting scale must be read in order to permit any substantial correction to be made. Furthermore, the altimeter setting positions which were found in the altimeters installed in this airplane are very reliable indications of the settings existing at the time of the accident. The
